**INTERNATIONAL CONGRESS
ON DETERIORATION
AND CONSERVATION OF STONE**

FOR AN EXECUTIVE PROJECT OF THE SPHINX ARCHAEOLOGICAL CONSERVATION

LUISA BONGRANI

GIUSEPPE FANFONI

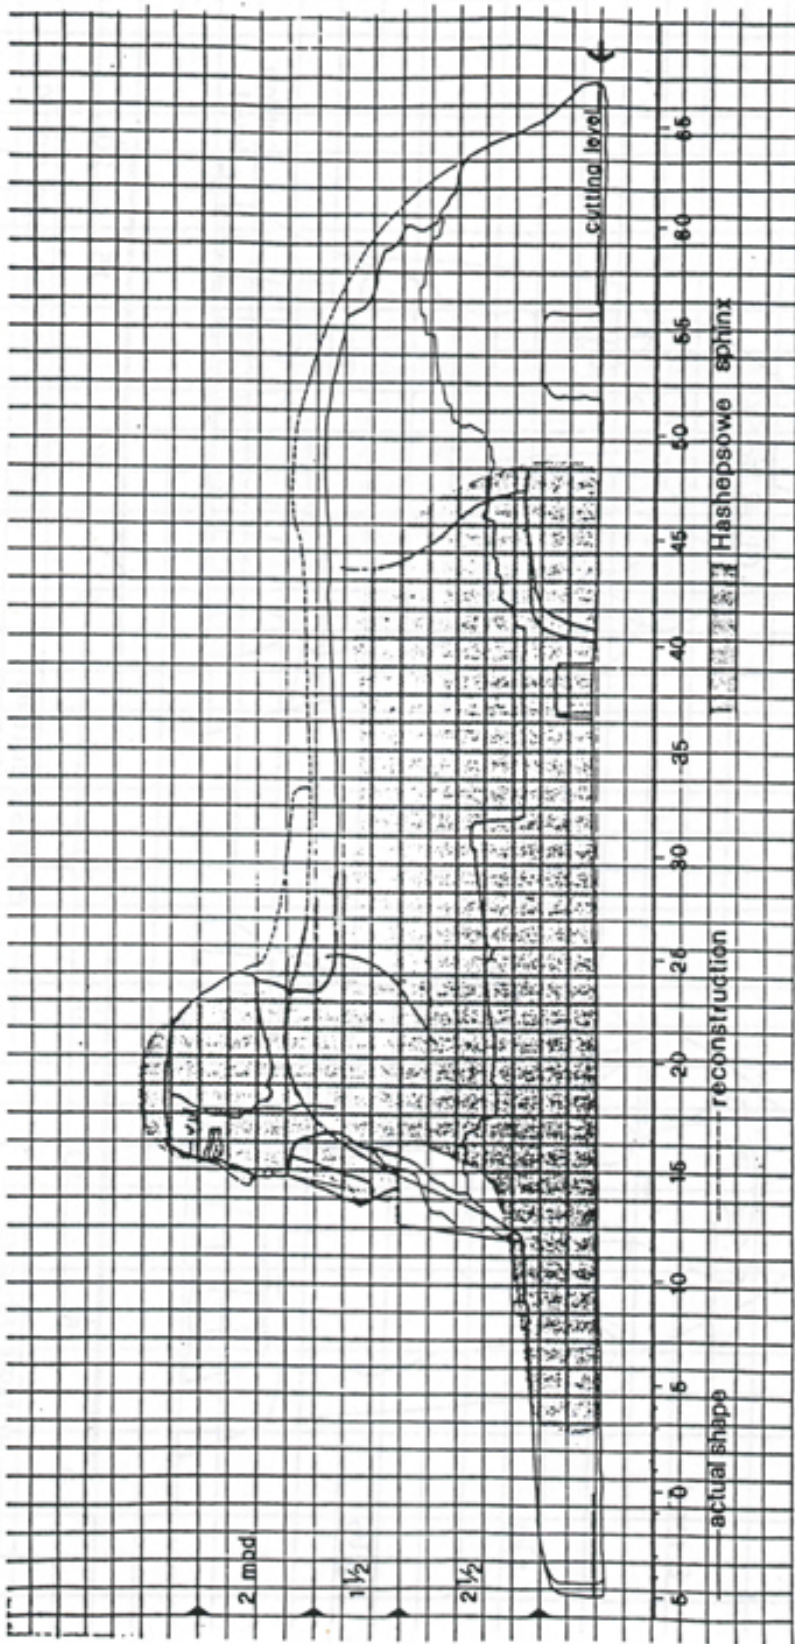
In the case of the Great Sphinx, since the face is well preserved, we may affirm that the prospect in the vertical proportions respects the "fixed canon" we find in the classical sphinxes; on the contrary the longitudinal proportion is much longer in comparison with the parallels [fig. 1]. We allow ourselves to propose that the choose was due to architectural and artistic considerations on the links between the mother-rock and the natural environment.

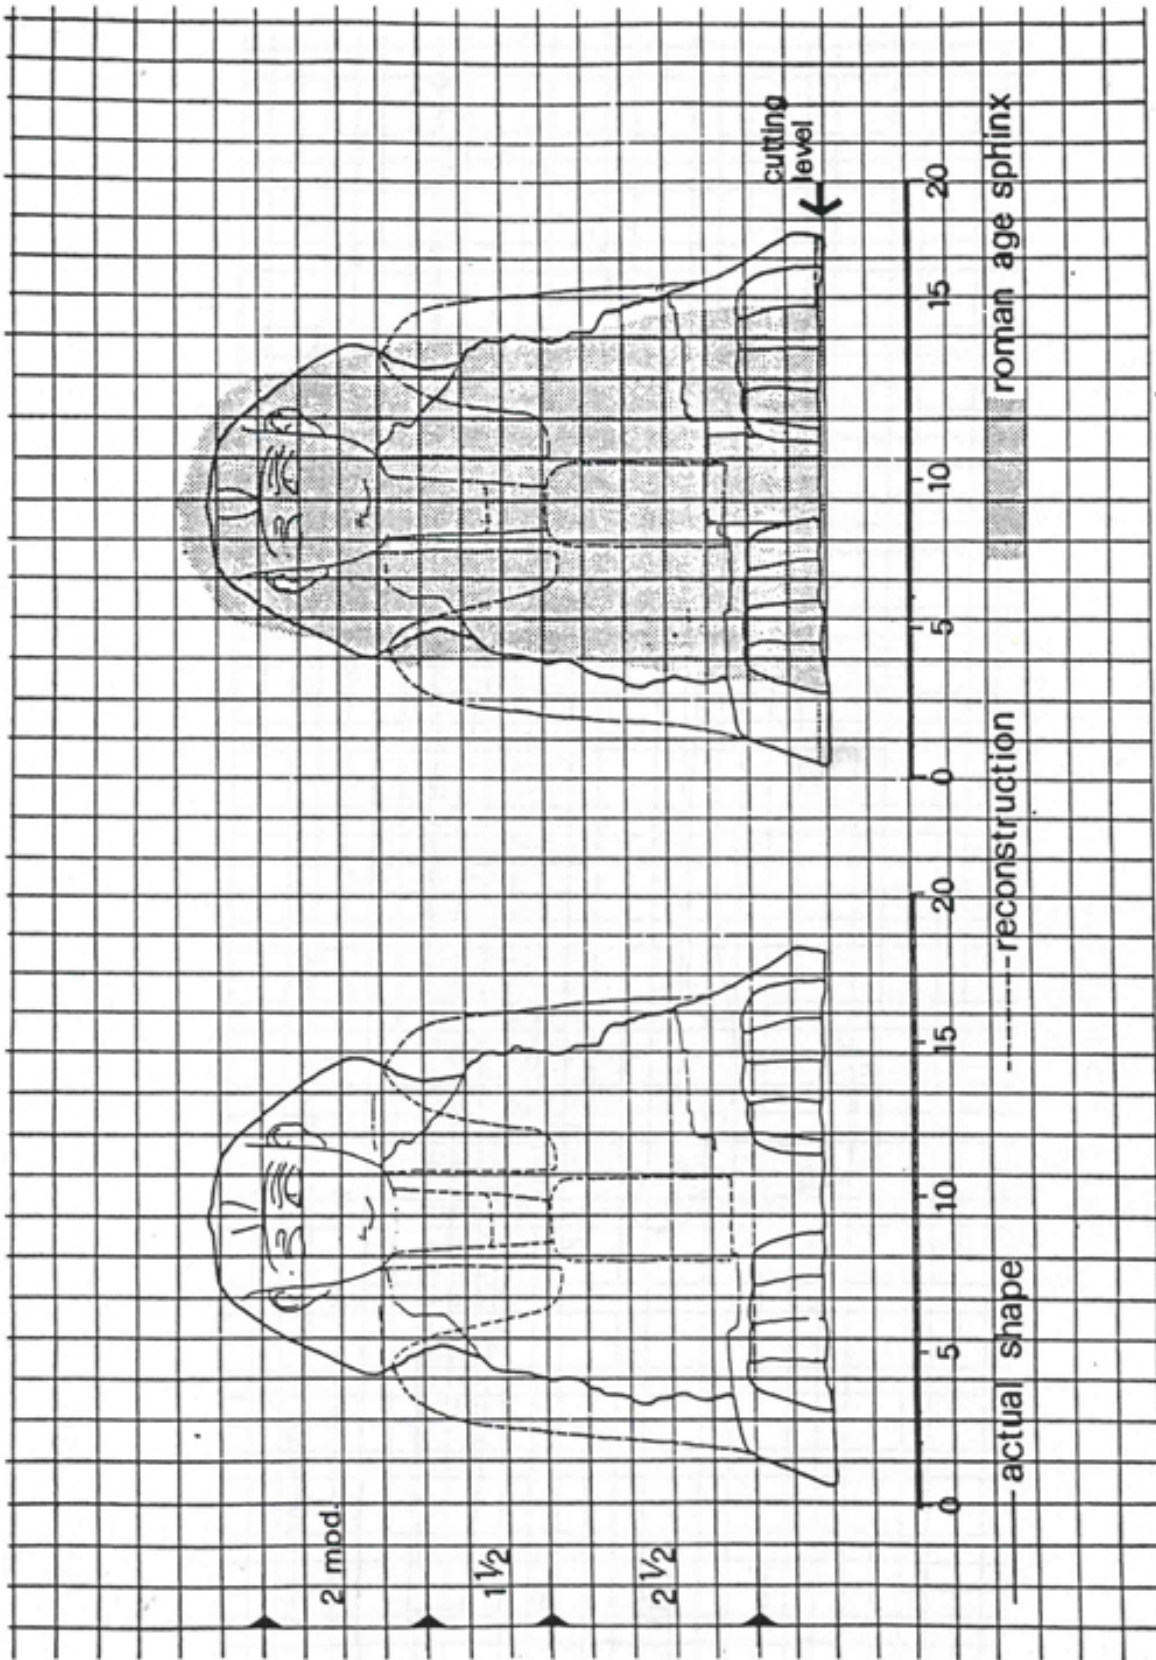
Besides, we know that the decay of the Sphinx had become evident since ancient times: the Roman sphinxes, without beard and so narrow in the shoulders in comparison with the classical ancient models, are more than probably reproducing the degraded Great Sphinx, as it had a special veneration in that period [fig. 2].
