**Proceedings Of  
The Egyptian - Italian Seminar**

## **ADVANCED RESTORATION TECHNIQUES AGAINST THE EFFECTS OF SOLUBLE SALTS IN THE STONE OF THE EGYPTIAN MONUMENTS**

Luisa Bongrani<sup>1</sup>, And Giuseppe Fanfoni<sup>2</sup>

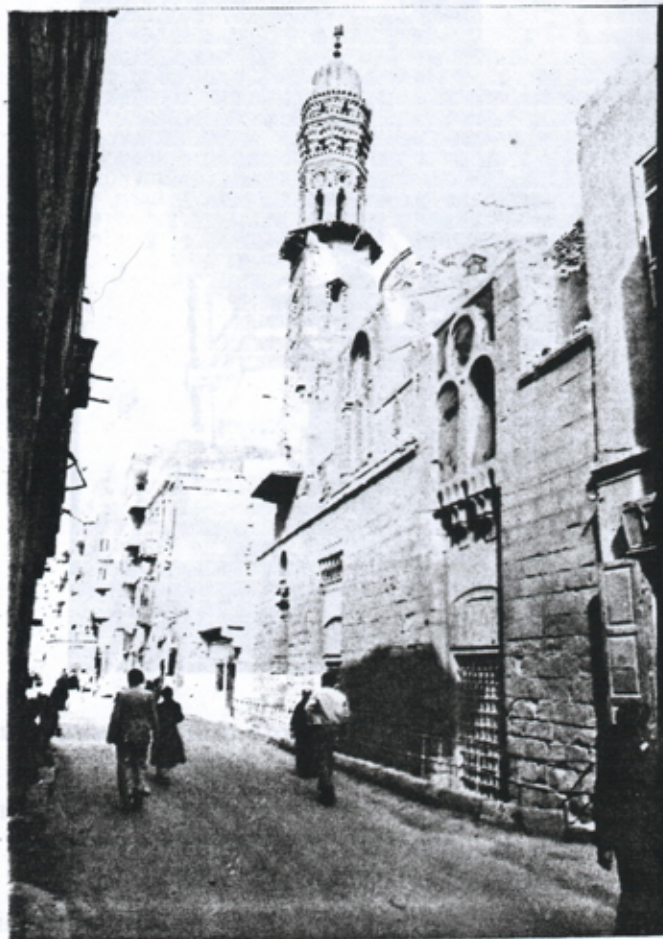
*The exterior of Hasan Sadaqa Mausoleum*

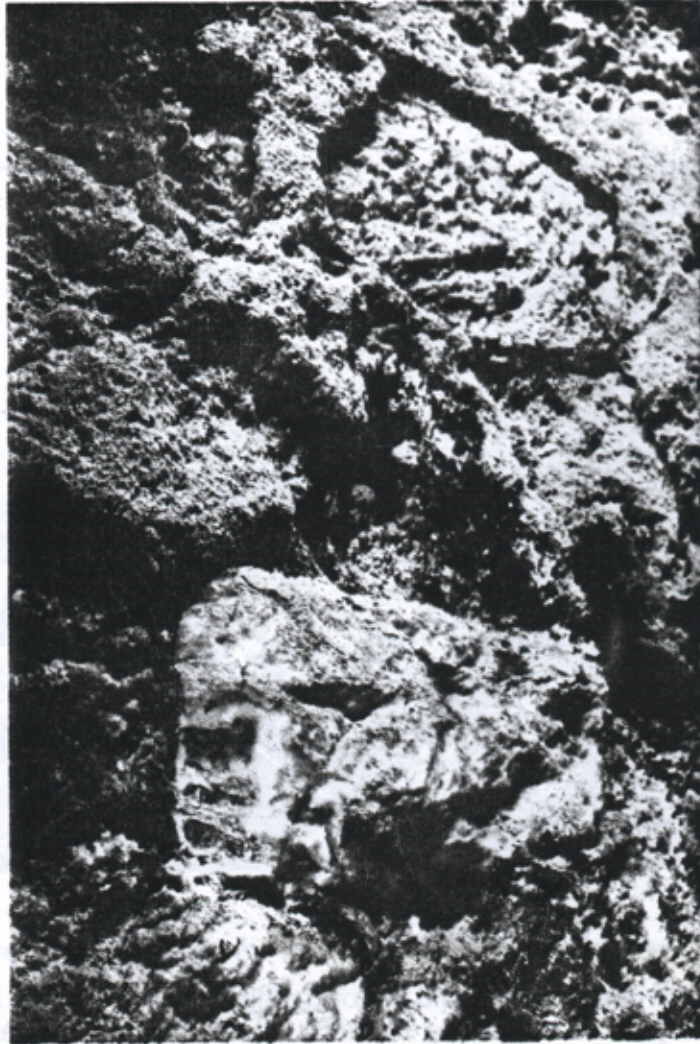
***A stone of the Madrasa wall at the upper level of humidity evaporation: the layer of salts is 2 cm. thick.***
